# Unexpected Voids

## Lessons Learned: Unexpected Voids

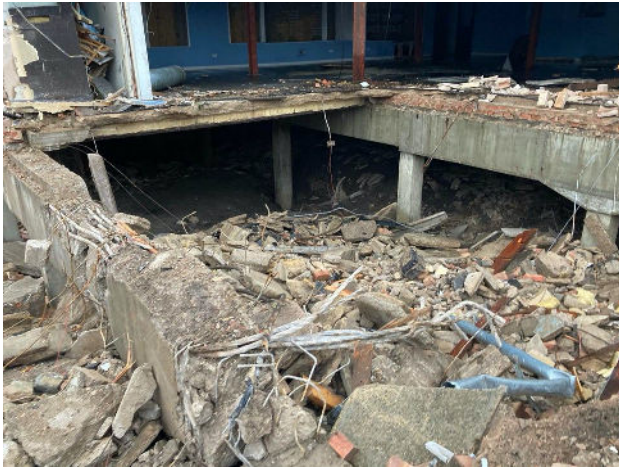
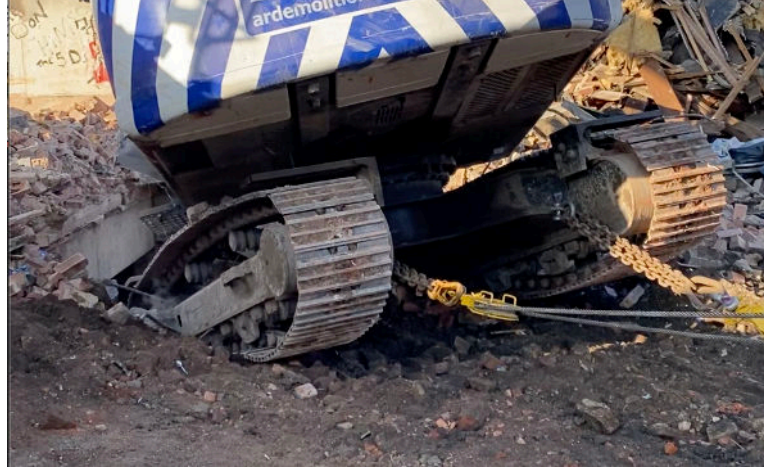
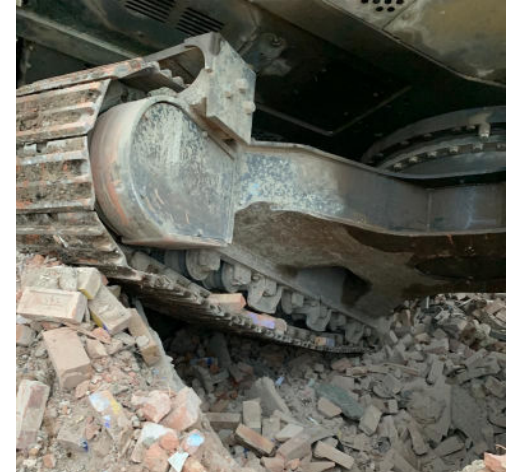
An unfortunate incident occurred involving the collapse of a ground floor slab after a demolition rig tracked above an unknown void. **Thankfully no one was injured**, however the incident serves as a stark reminder of the inherent dangers within demolition works.

A full investigation is ongoing into the incident. Early findings outline that the structure had been constructed on columns with a suspended ground floor slab, creating a **tapered void** measuring at various depths ranging from appx 0.1m to 3m across opposite ends of the structure.

The structure itself, the site features and the adjacent areas around the structure also did not indicate the presence of the void or any varying ground levels beneath the ground floor slab.

Whilst **Ground investigation reports** had been produced for the site (including physical bore holes samples) these were taken around the structure. The results of which **did not indicate the presence of any void**. In addition, the underground void was **not identified on any site drawings**, reports or information.

Site inspections prior to the works also failed to identify any normal signs or indication of the presence of the underground void. e.g. service hatches, service runs, vents or openings.

Prior to the incident areas of the structure above the ground floor slab had been demolished and tracked over, without incident or indication that the slab was suspended. This **area had been checked by the plant operator** which was clearly proved to be ineffective.

- Whilst a degree of information was available prior to this incident, it is common place in demolition to have **little or no historic information** on the structure or site. As demolition professionals we need to educate and advise **Clients / Principal Designers** of the level of information and surveys required for our works to be designed and delivered safely.

- Whilst visual & physical investigations, surveys and inspections of the structure are a vital control, the use of further tools such as GPR should be used more common place.

- The physical marking out and exclusion around underground hazards are a key final barrier in avoiding collapses and should be adopted at all times.
- Intrusive or physical checks should be undertaken by plant operators to assess the ground prior to tracking over new or changing areas of a structure.
